# Safety Notice 008/19

### Set up of neonatal resuscitaires

#### 24 June 2019

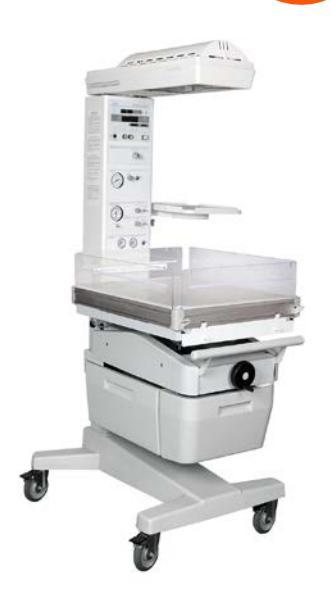
Example of resuscitaire with integrated air/oxygen blenders

A resuscitaire is a piece of equipment used to warm and resuscitate newborns post birth. This equipment is often found in Birthing/Delivery Suites, Maternity Wards, Neonatal Units, Operating Theatres and Emergency Departments. In NSW, some models have integrated (built in) air/oxygen blenders while other models have external blenders. Refer to page 2 for examples.
