Safety Alert 001/09

PEEP Valve, Expiration Diverter Assembly

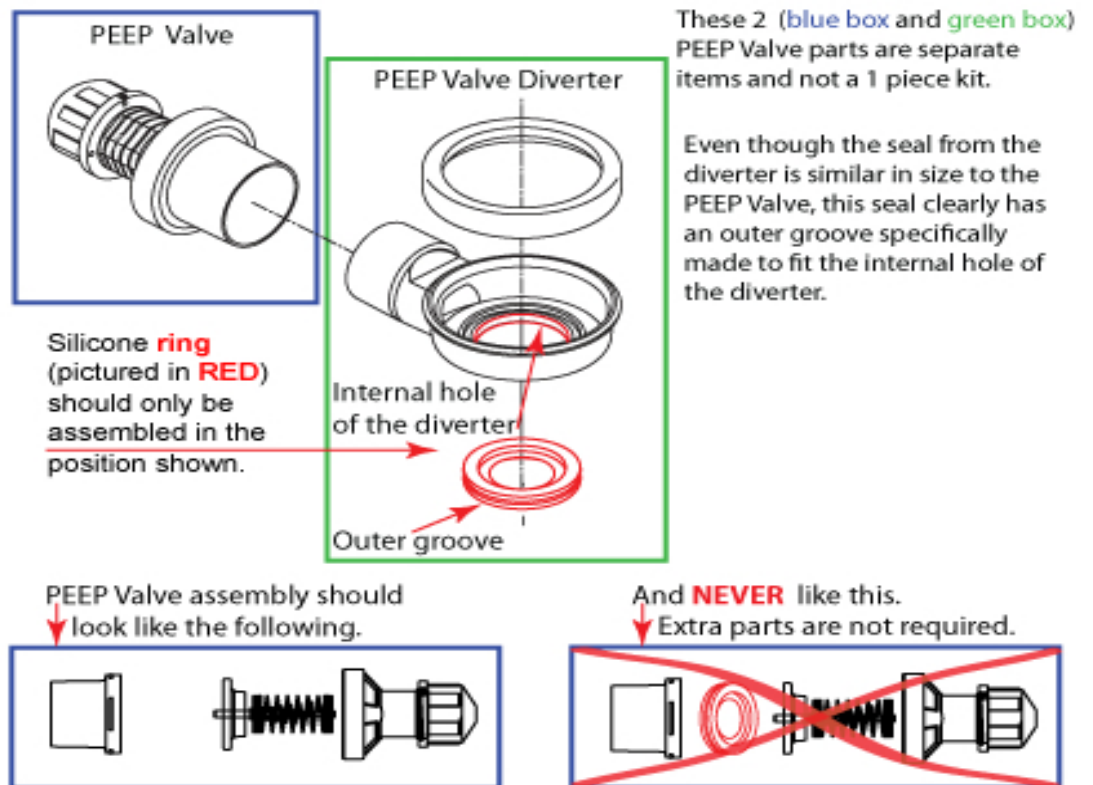
NSW Health has recently been notified of a patient's misadventure due to incorrect assembly of a PEEP Valve. It has been noted that the Peep Valve can be assembled with the Silicone Ring that is part of the Peep Valve Expiration Diverter. When this Ring is inserted into the incorrect spot it will impede the PEEP valve from working correctly. This error can occur because the Silicone Ring is shaped to fit perfectly in both the correct (in the Peep Valve Diverter) and incorrect (in the Peep Valve) position [see diagrams below]. When this error occurs the expiration phase of ventilation is impaired leading to high intra- thoracic pressures.

- It is recommended that a laminated instruction sheet be located close to where the equipment is being assembled, and testing of equipment (including resuscitation bag, PEEP valve and diverter) occurs prior to use.
- Checking of resuscitation equipment should be undertaken regularly by appropriately skilled personnel, to ensure equipment is assembled and functioning correctly.

1. Laminated instructions to be located in all areas where assembly occurs.
2. Checking of resuscitation equipment is undertaken by skilled staff prior to use.
