Issue date
3 August 2023

PrisMax Continuous Renal Replacement Therapy Device: B2222 Alarm

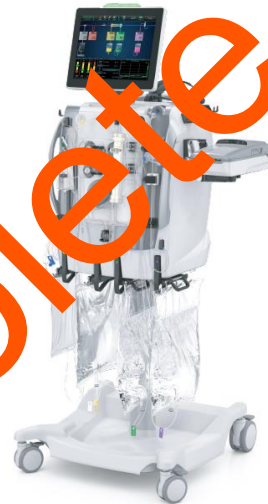
PrisMax is a Continuous Renal Replacement Therapy device used in critical care environments. Since Software Version 3.2 was introduced in February 2022 there have been multiple “system failure” alarms (known as B2222 alarm). The alarm can occur at any stage of the therapy and, depending on the machine, may allow resumption of treatment or be unrecoverable and end treatment. If treatment ends, blood in the circuit may be unable to be returned to the patient, resulting in unacceptable blood loss. Baxter are working with affected sites and have provided education and slides to assist staff to navigate the alarm.
